CASE STUDY: CS-18 Quarry

Site:	Holcim Quarry
Application:	Jaw liner and Toggle bolts on a Terex Jaques 42 x 36 Jaw crusher
Original Set-Up:	1-1/2" UNC hex nuts tightened with a flogging spanner
Issues Experienced:	<ul style="list-style-type: none">● OH&S concerns associated with flogging spanners and impact tooling● very time consuming● difficult and confined location● Due to incorrect bolt loads being applied units continually vibrate loose during operation
Technofast Product Used:	EziTite [®] Hydraulic Nuts and polywahers
Benefits Experienced:	<ul style="list-style-type: none">● Easy installation and handling● removed major OH&S concerns● Nuts no longer vibrate loose during operation
Installation Time:	Old Method = 2 hours 30 minutes (3-4 personnel) New Method = 30 minutes(2 personnel)
	Time Saving = 2 hours
Feedback Received:	"The use of the EziTite hydraulic nuts has improved site safety and increase production as a result of not having to stop the machine to retighten loose bolts"

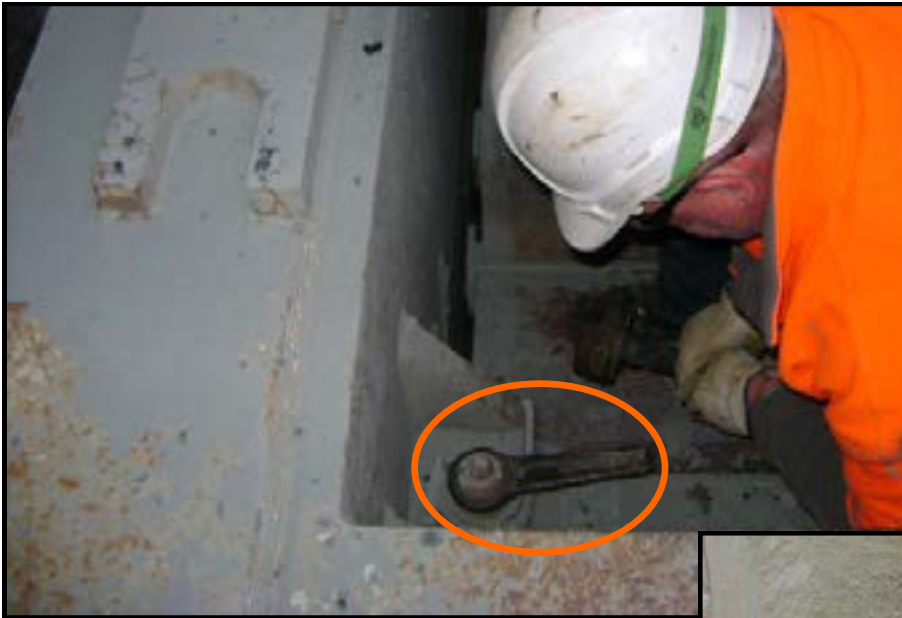
Use of flogging spanners in such tight locations meant inadequate bolt load was being applied and there were several OH&S Concerns

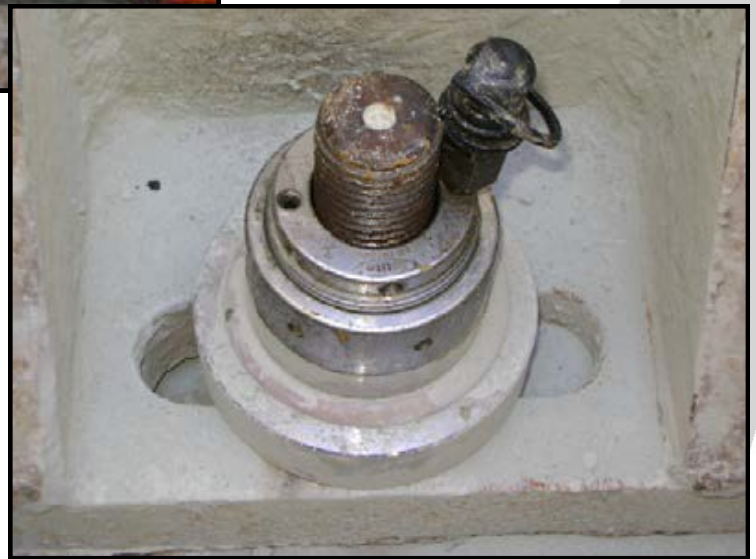
EziTite[®] Hydraulic Nut installed with polywasher.
