CASE STUDY: CS-08

Copper & Gold Mine

Site:	Earnest Henry Mine
Application:	Shell Bolting on ThyssenKrupp gyratory crusher
Original Set-Up:	Thirty six M72 Nuts and bolts tightened with hydraulic torque wrenches
Issues Experienced:	<ul style="list-style-type: none">● No Control of bolt load● Difficult and confined location● Nuts loosening during operation● OH&S issues with the use of hydraulic torque wrenches
Technofast Product Used:	Special M72 x 6.0 High Tensile EziTite® Hydraulic Nuts
Benefits Experienced:	<ul style="list-style-type: none">● Easy installation and handling● Removed the need for hydraulic torque wrenches improving OH&S● Precise bolt load achieved● Units remained tight throughout operation period
Installation Time:	Old Method = 12 hours (4-5 personnel) New Method = 4 hours (2-3 personnel) Time Saving = 8 hours
Feedback Received:	“Installation went extremely smoothly with shells being closed together evenly. Very little physical effort was required to operate the units” QA Engineer

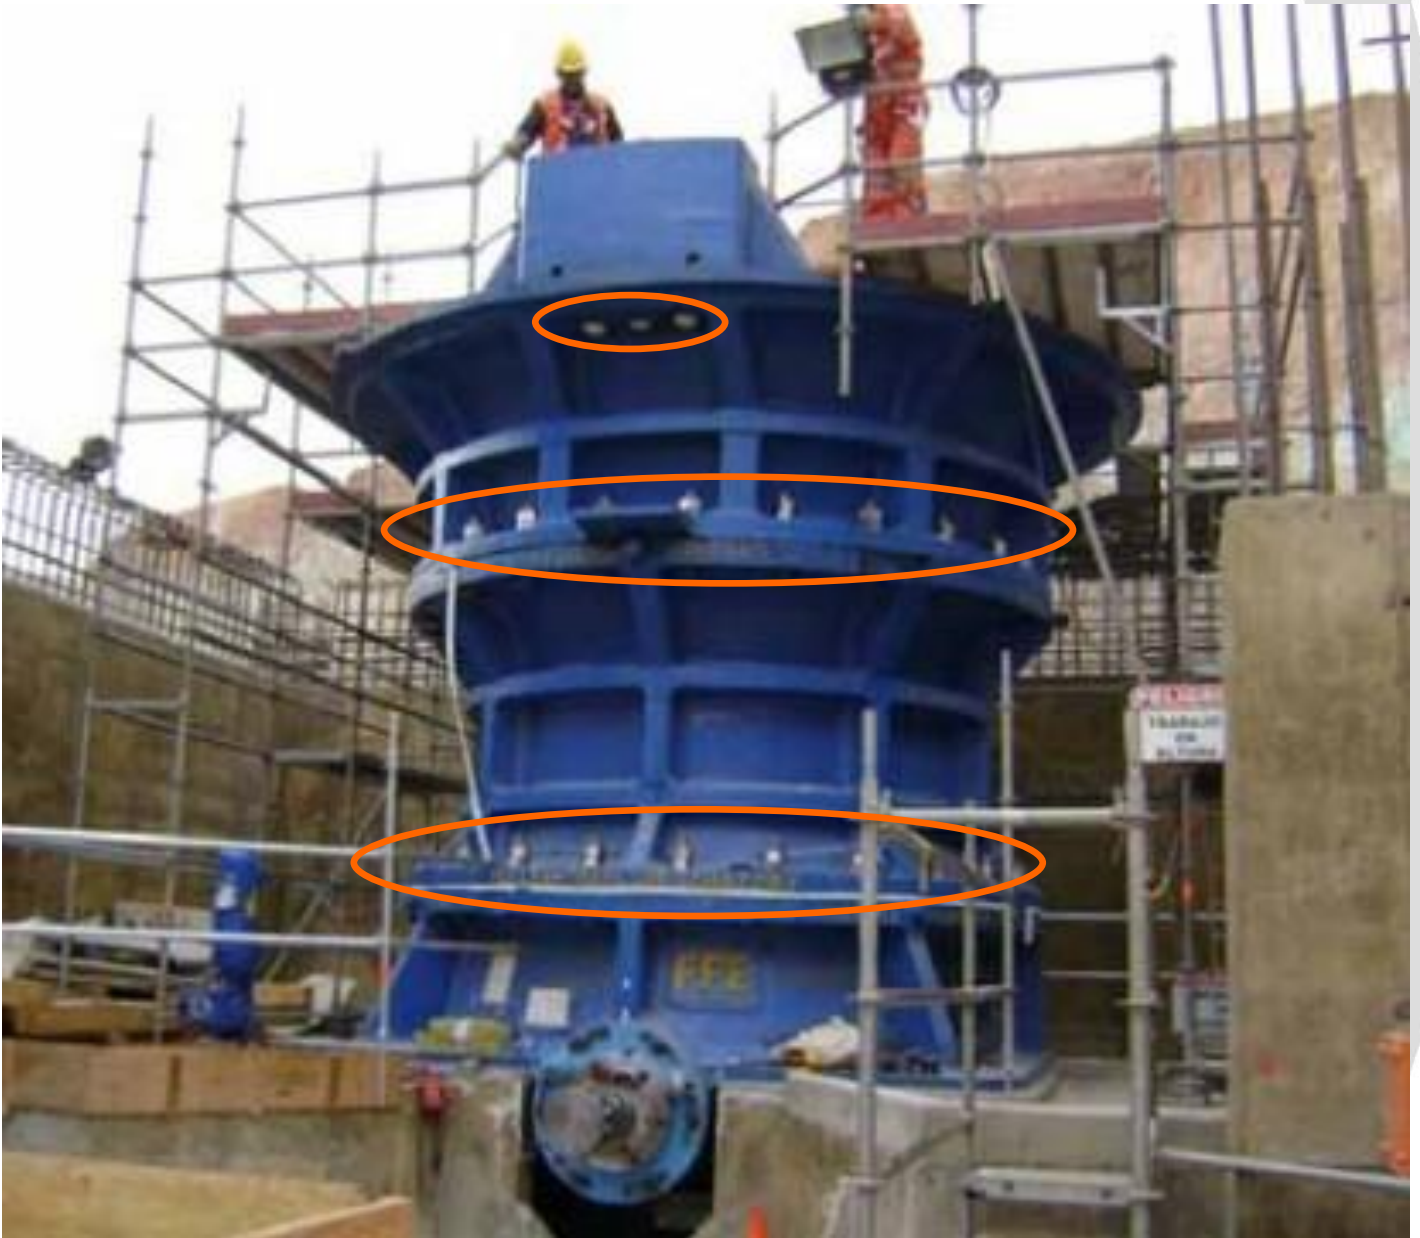
EziTite® Hydraulic Nuts installed prior to commissioning of new crusher..
